A DRAINAGE PROBLEM IN SOUTH COLUMBUS,  
WITH POSSIBLE SOLUTIONS

PRESENTED IN PARTIAL FULFILLMENT OF THE REQUIREMENTS  
FOR THE DEGREE OF BACHELOR OF SCIENCE  
OHIO STATE UNIVERSITY  
1983

MICHAEL D. BUGENSTEIN

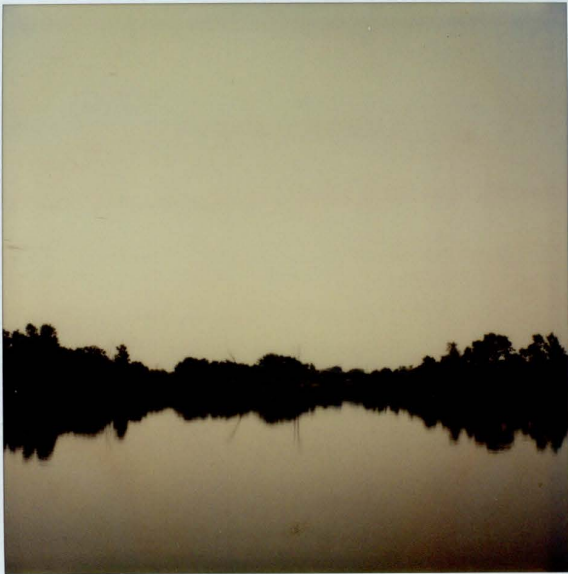
Fig. 1. View of the lake, looking south from the north shore

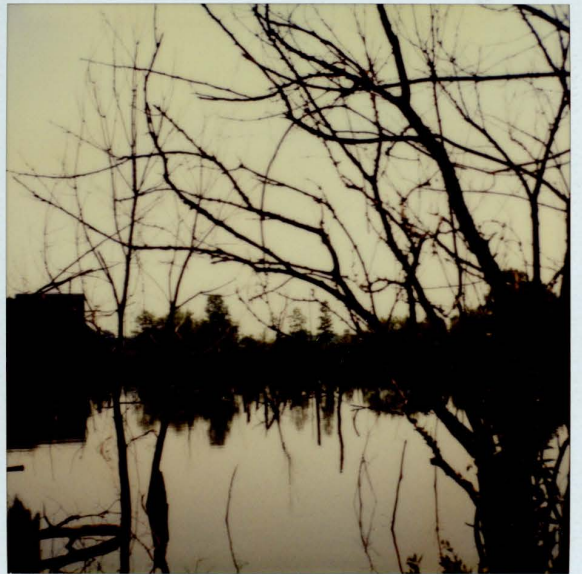
Fig. 2. View of the lake looking east from its western shore.

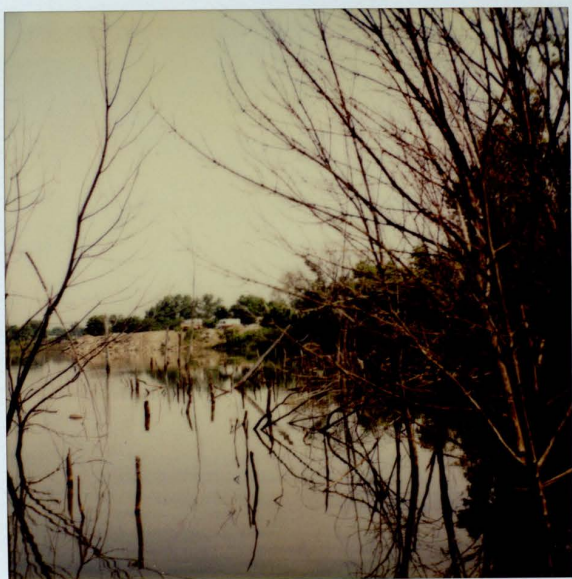
Continuing along the eastern shoreline, one notices a dirt road leading from High Street westward that has been flooded by the lake. Still farther north, extensive filling is taking place, which juts into the lake from the northeast. The fill is about 12 feet above the surface of the lake. At that point the shoreline switches direction abruptly westward to complete the loop. Along the northern shore, the lake abuts the marshy area which has been described.

Fig. 3. View of the lake from its southern shore, looking northward. Note fill at left.

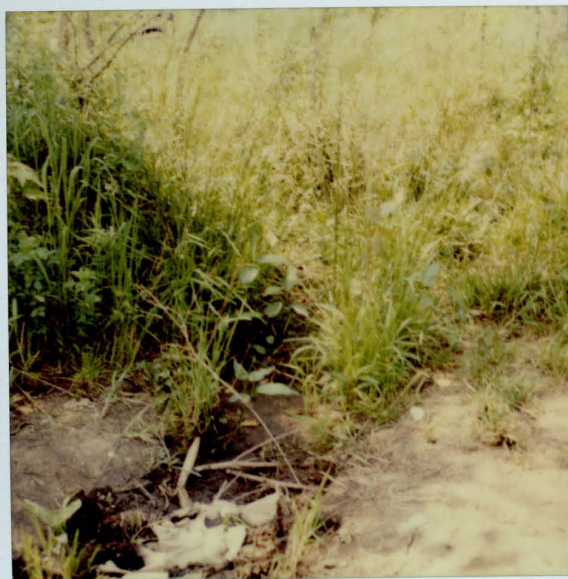
Along the south side of the lake, the pattern of erosion is the same. In the southeast corner, the relief disappears, and a drainage channel has been naturally excavated toward the south-southeast. The drainage velocity was estimated to be less than a knot. Fish can be found swimming in the drainage channel at some times during the day. Surface drainage had stopped by early June.

Fig. 4. The dry drainage channel leading from the southeast corner of the lake. June 11, 1983.

The most obvious solution would be to completely drain the lake by placing an eight inch plastic field pipe in a trench about seven feet deep. This pipe could then be connected with the catch basin on the Vick property and eventually the lake would drain and diminish in area. The remaining depressions could then be filled in. The benefits of draining the lake are obvious: the land which is presently under water could be farmed, and a neighborhood breeding ground for insects would be eliminated. The excavation and pipe-laying should be professionally done. Estimates should be obtained before any work is done, and the quality of work should not be

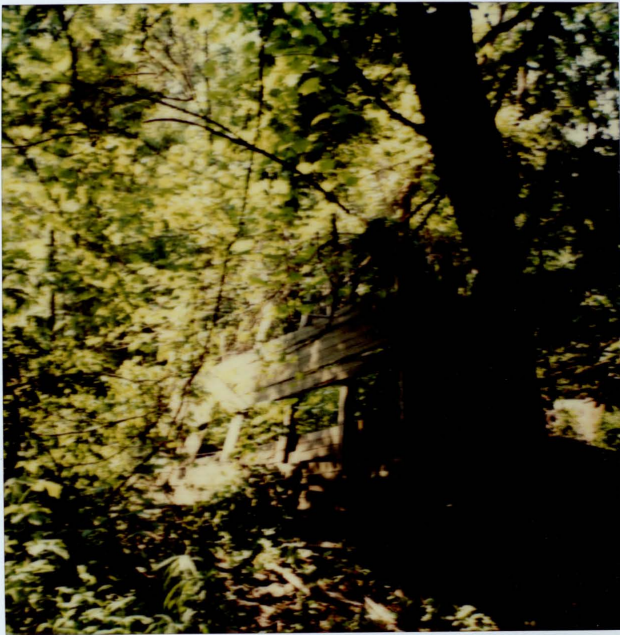
Fig. 5. Ruins of old check point  
on the Ohio Canal.

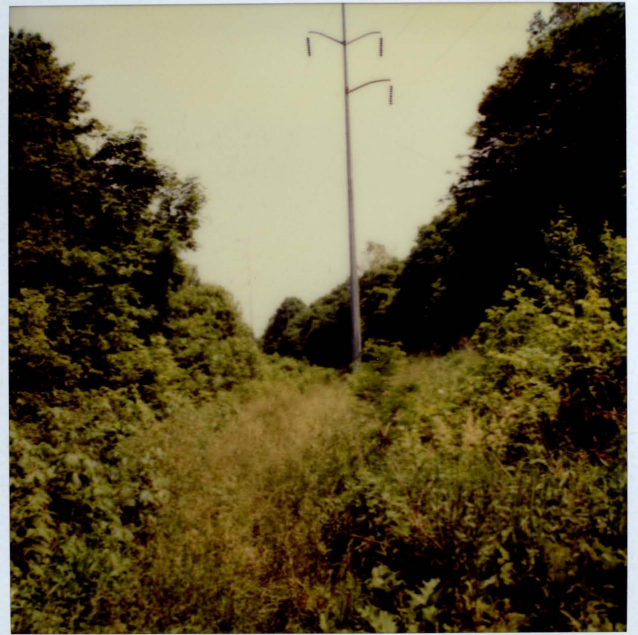
Fig. 6. Dry channel of the Ohio  
Canal, abandoned around  
1890. Scioto River is out  
of picture to the left,  
looking upstream.
